Strand Lighting

Document : 7Z0046

M24 UPGRADES HANDBOOK

1.1 Tempus M24 Console Motherboard Ref. I832

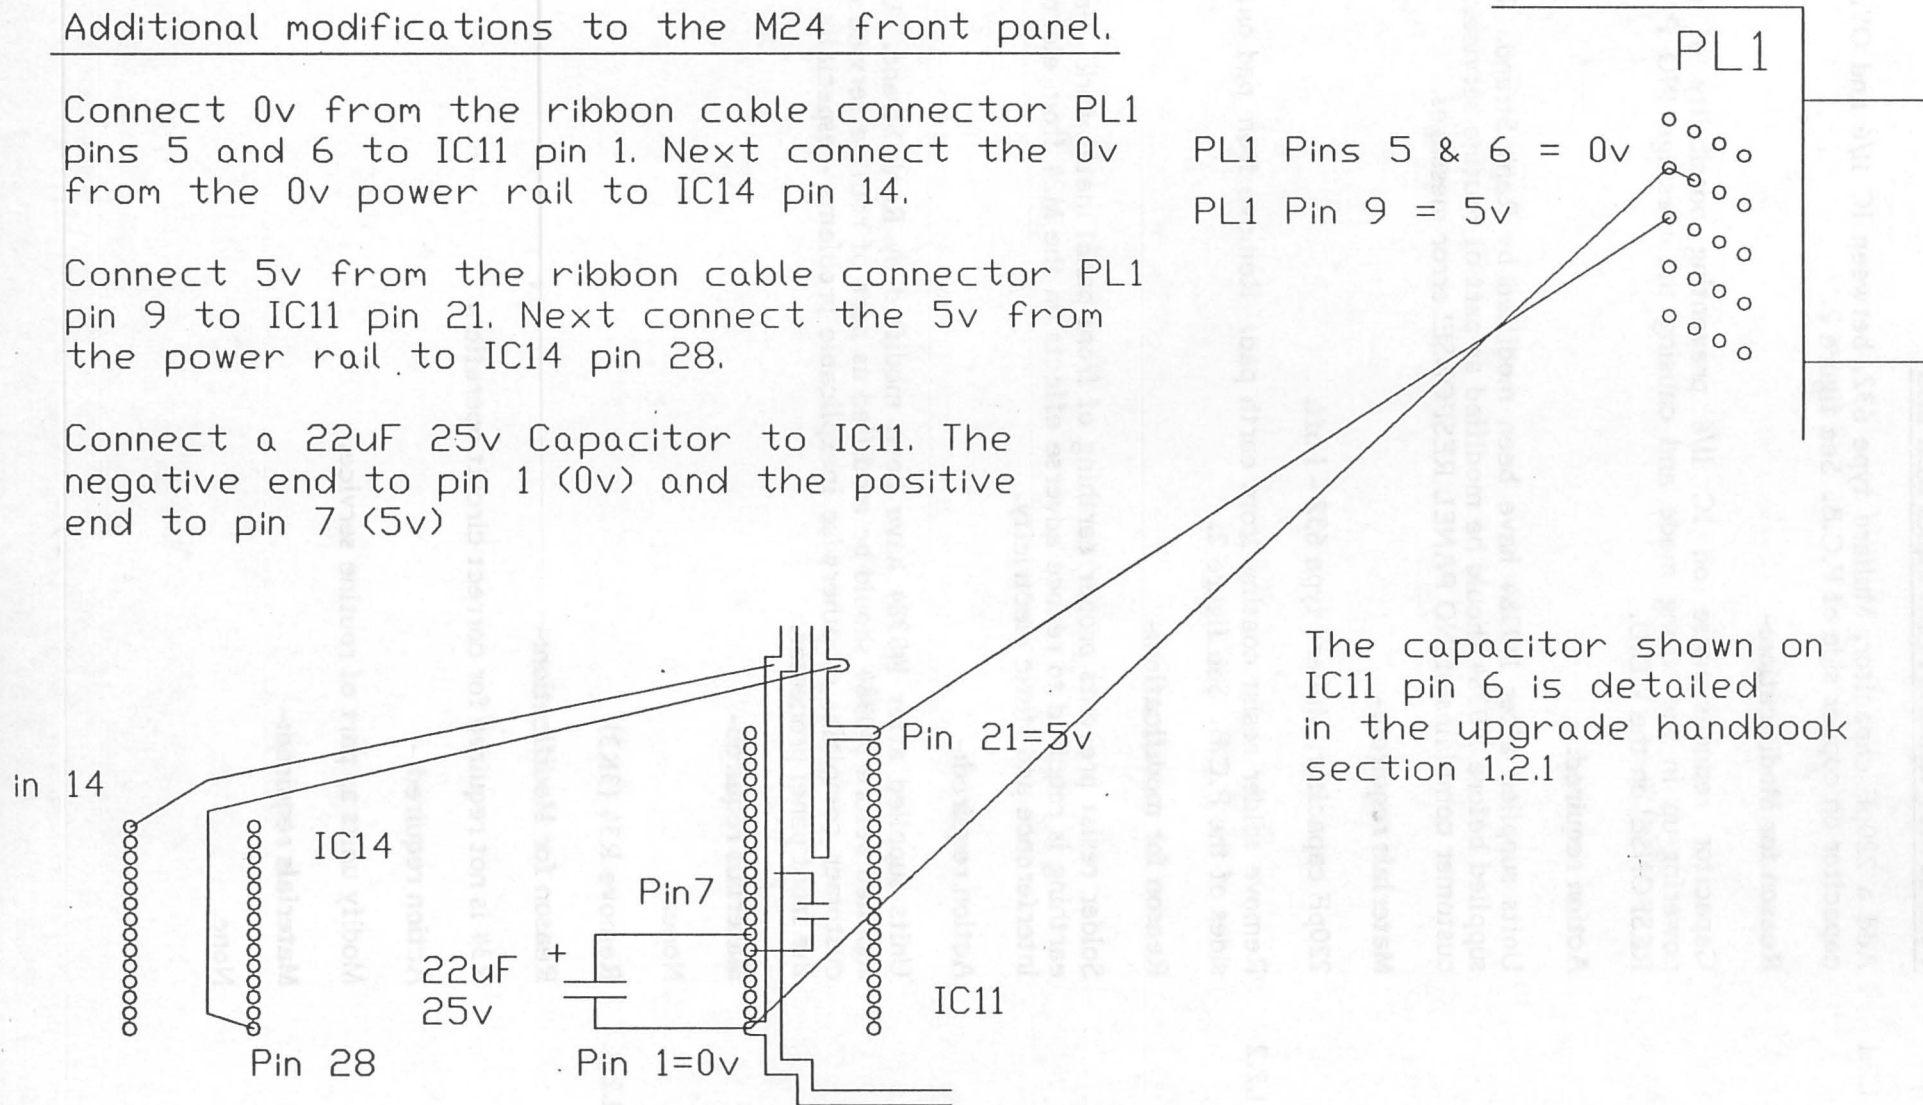
Connect 0v from the ribbon cable connector PL1 pins 5 and 6 to IC11 pin 1. Next connect the 0v from the 0v power rail to IC14 pin 14.

Connect 5v from the ribbon cable connector PL1 pin 9 to IC11 pin 21. Next connect the 5v from the power rail to IC14 pin 28.

Connect a 22uF 25v Capacitor to IC11. The negative end to pin 1 (0v) and the positive end to pin 7 (5v)

The capacitor shown on IC11 pin 6 is detailed in the upgrade handbook section 1.2.1

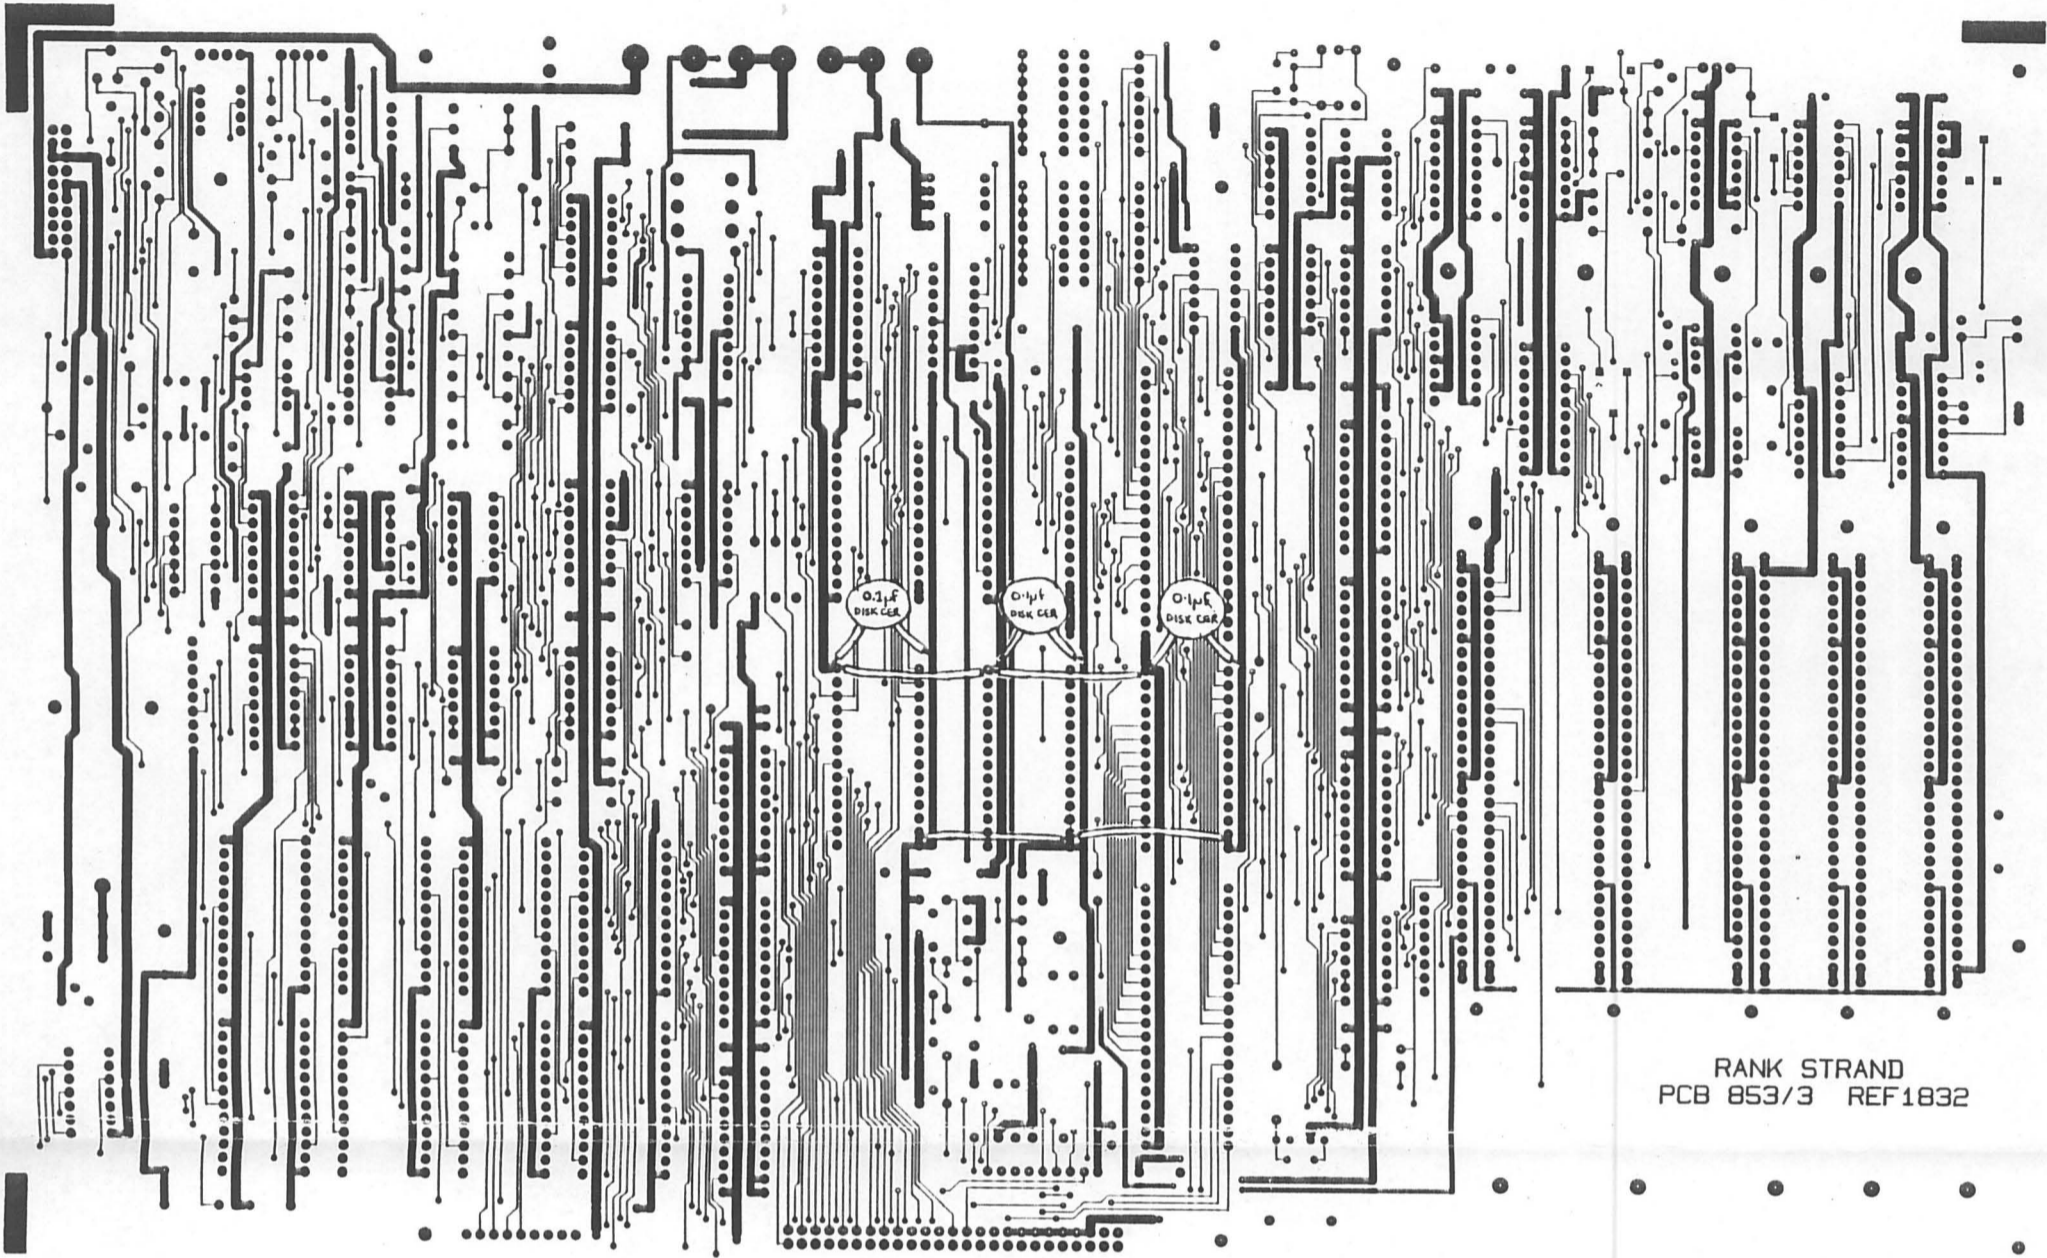
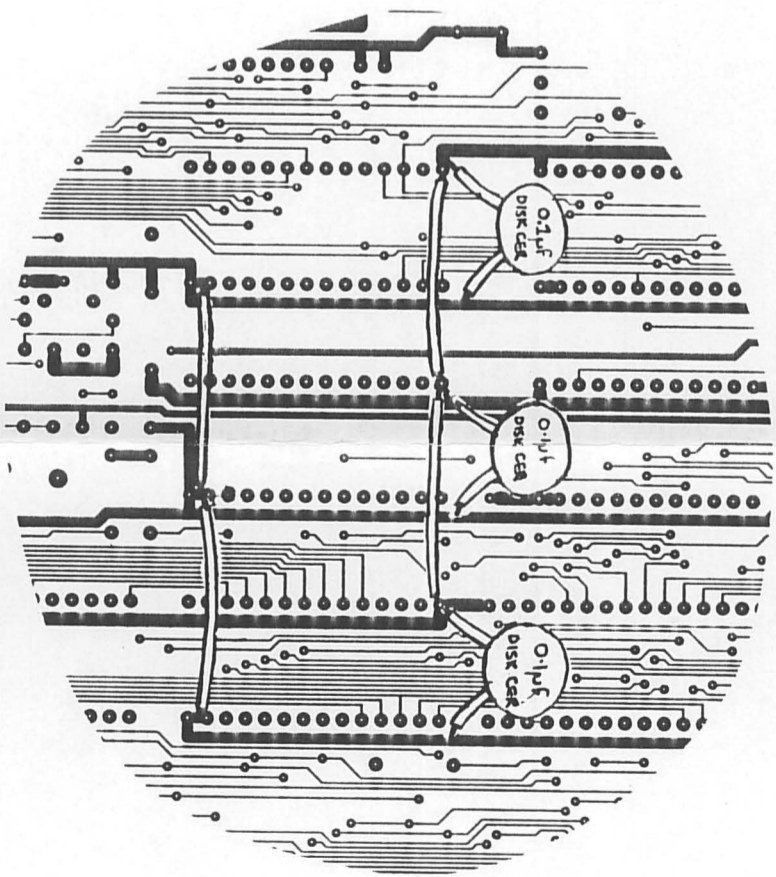
FIGURE 1

- 1.1.1 Using 0.5mm² PTFE insulated wire, link IC 22/14 to IC 25/14 to IC 29/14, link IC 22/28 to IC 25/28 to IC 29/28.

Add a 0.1 F 50V disc ceramic capacitor between pins 14 and 28 on each of IC's 22, 25, 29. Attach the capacitors on the copper side of the P.C.B. and make the leads as short as possible.

The instantaneous power demand of PROM's IC's 22, 25, 29 can generate severe noise spikes on the 0V and +5V power rails causing incorrect microprocessor action, and system failure. The addition of the wire links and capacitors reduces the power rail impedance.

All units supplied after 140384 have been modified by Rank Strand. Units supplied before 140384 should be modified as part of routine service, or if the customer experiences inexplicable system 'crashes'.

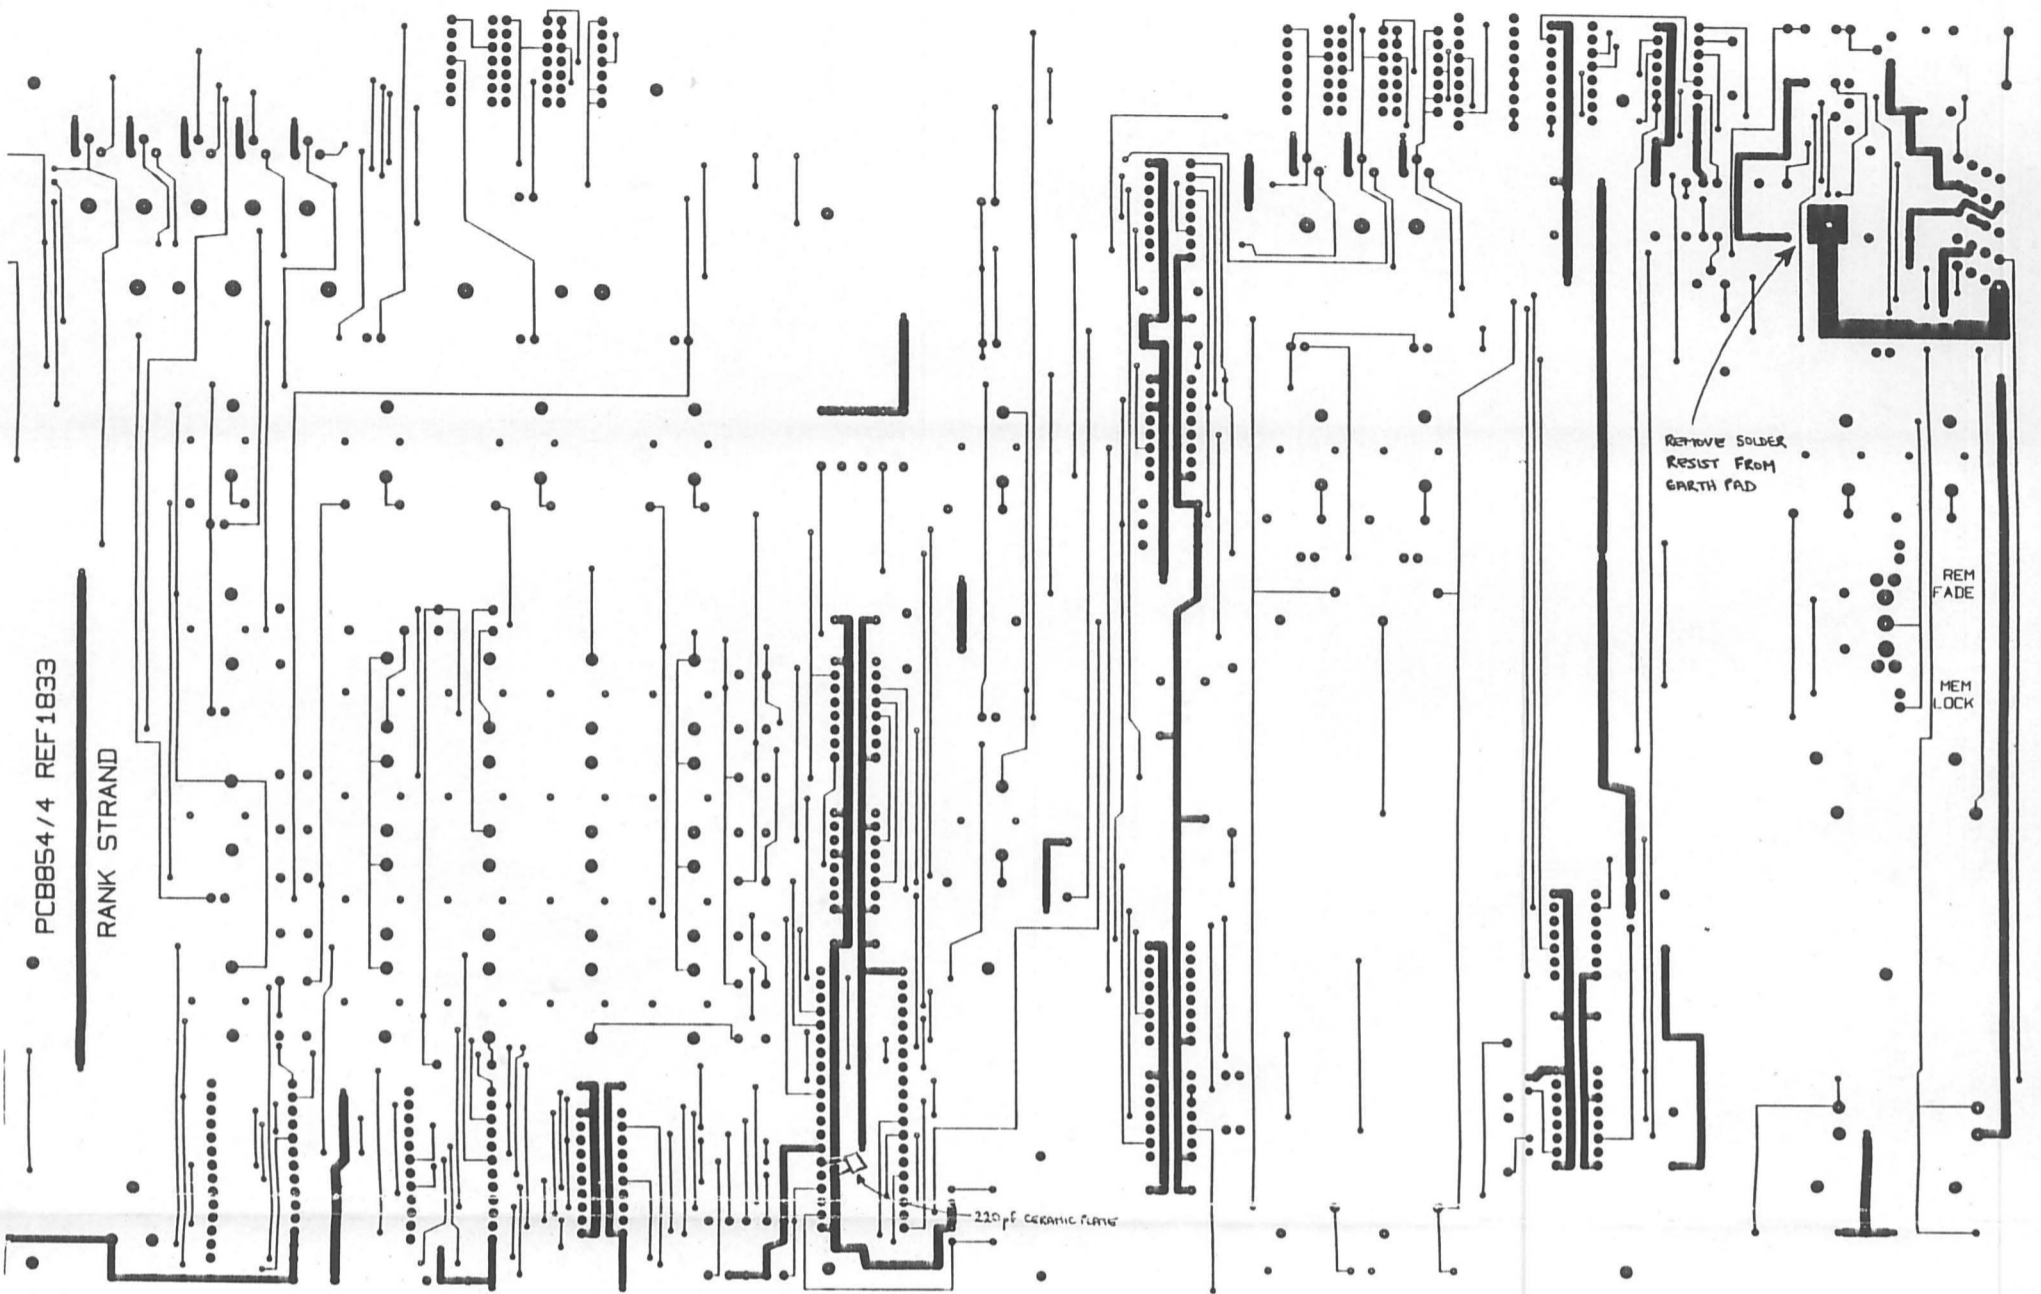
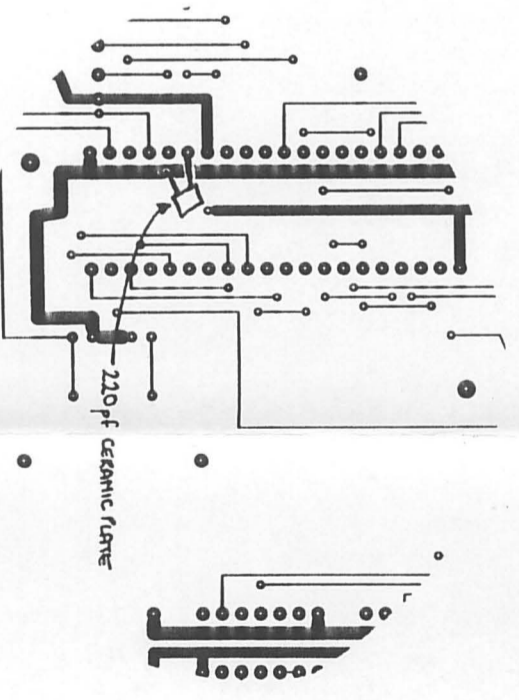
DETAILS OF MODIFICATION 1.2.1

- 1.2.1 Add a 220pF capacitor, Mullard type 632, between IC 11/6 and OV. Fit capacitor on copper side of P.C.B. See figure 2.

Capacitor reduces noise on IC 11/6 preventing possibility of panel powering-up in the wrong mode and causing the message 'NO PANEL RESPONSE' on the V.D.U.

Units supplied after 140384 have been modified by Rank Strand. Units supplied before 140384 should be modified as part of routine service, or if customer complains of 'NO PANEL RESPONSE' error messages.

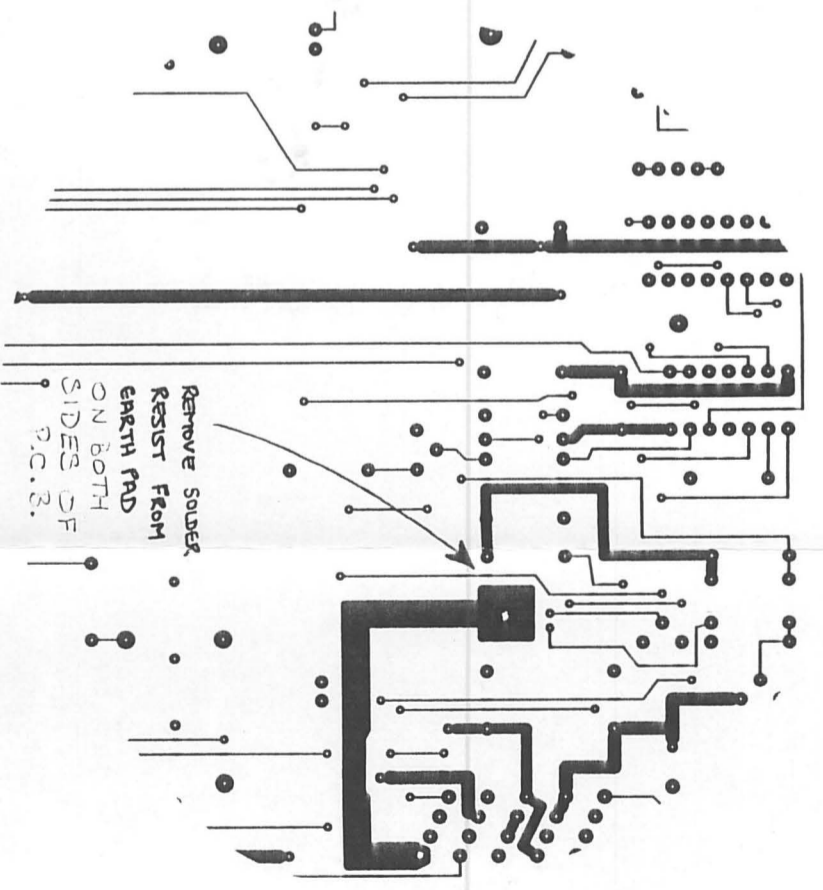
FIGURE 2

- 1.2.2 Remove solder resist coating from earth pad. Remove from pad on both sides of the P.C.B. See figure 2.

Solder resist prevents proper earthing of front panel metal work. Proper earthing is required to reduce adverse effects on the M24 from electrical interference and static electricity.

Units supplied after 140384 have been modified by Rank Strand. Units supplied before 140384 should be modified as part of routine service or if customer complains of otherwise inexplicable problems - especially with the front panel processor.

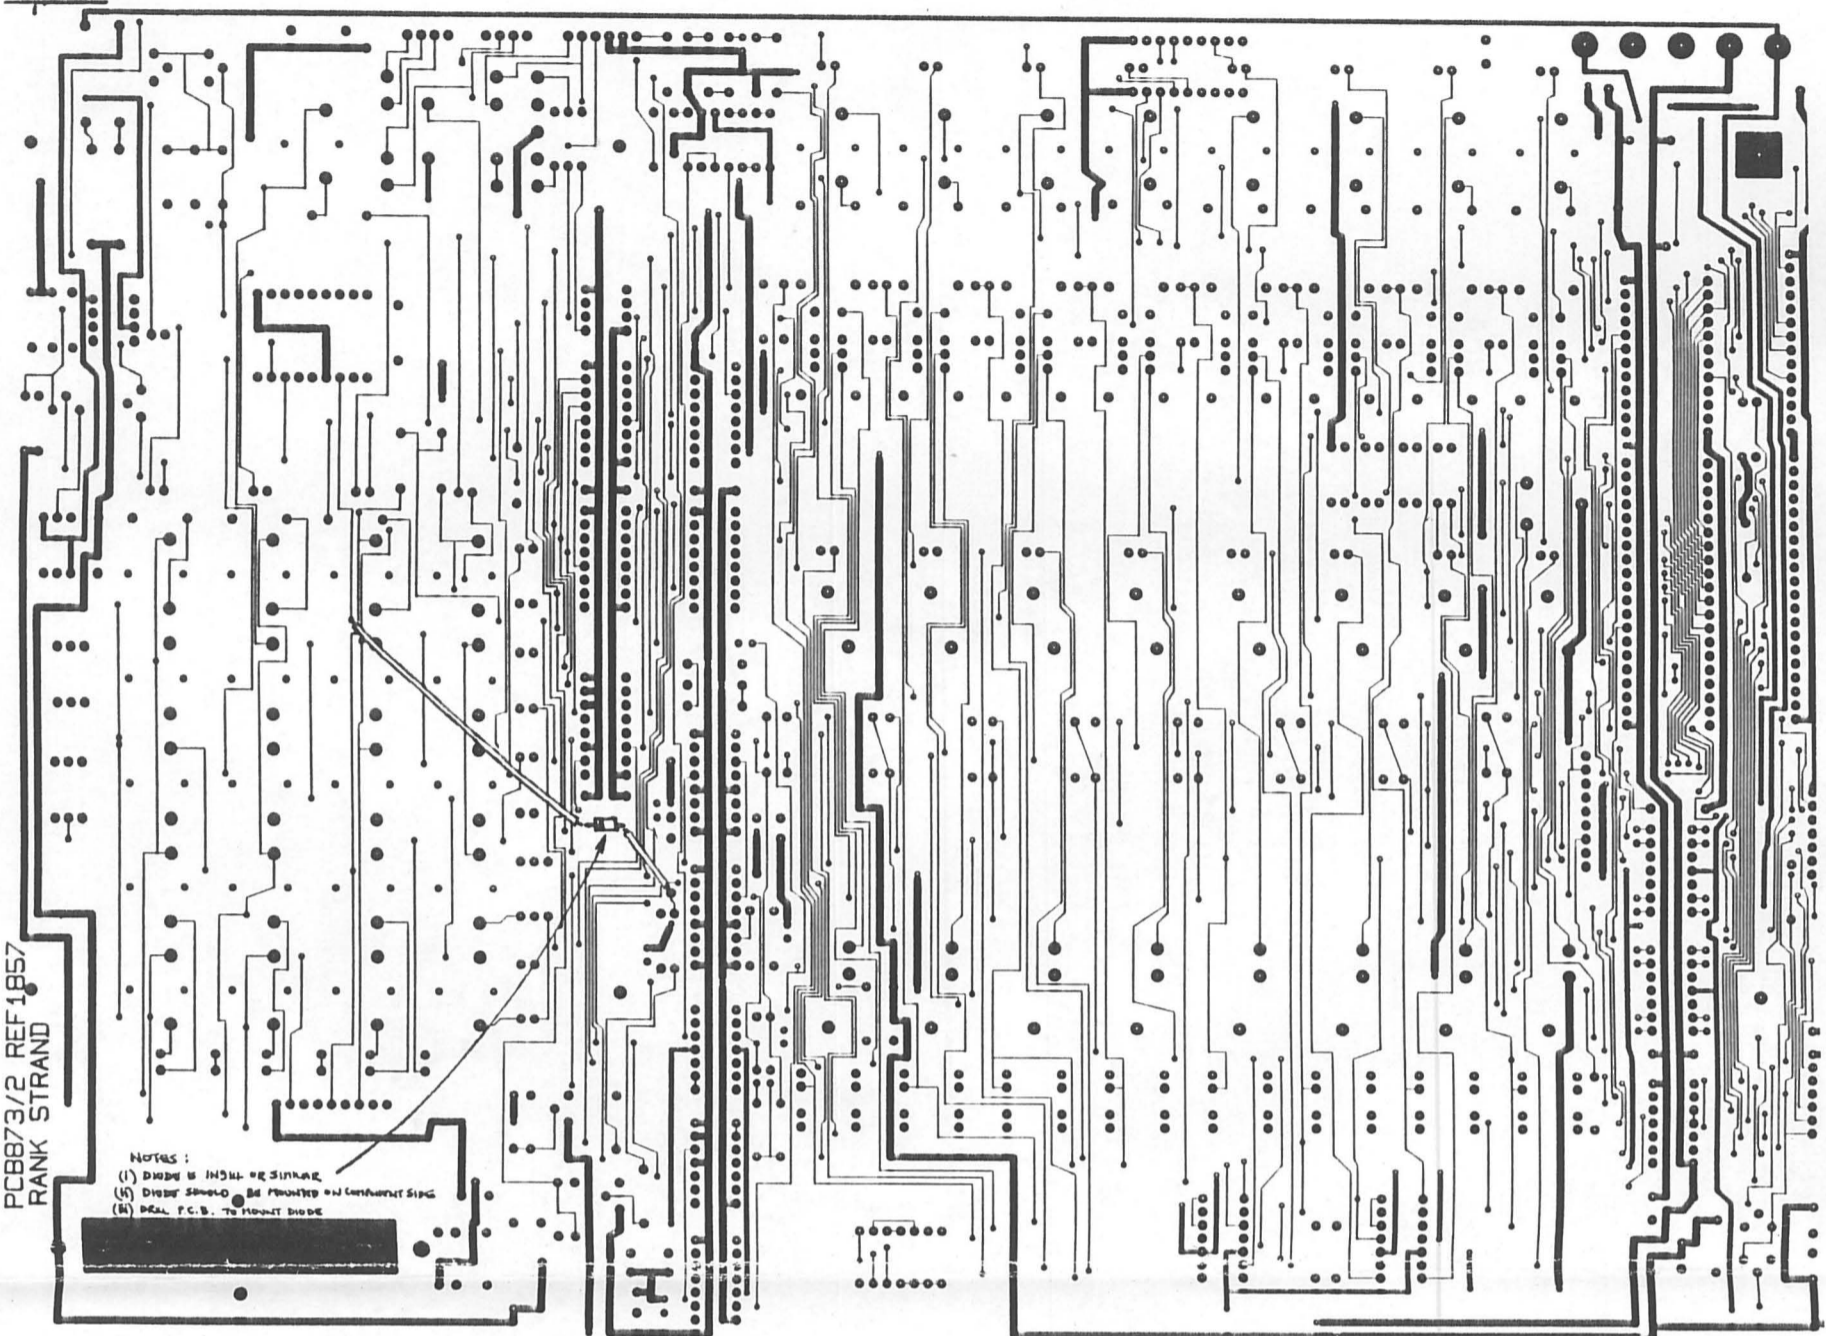
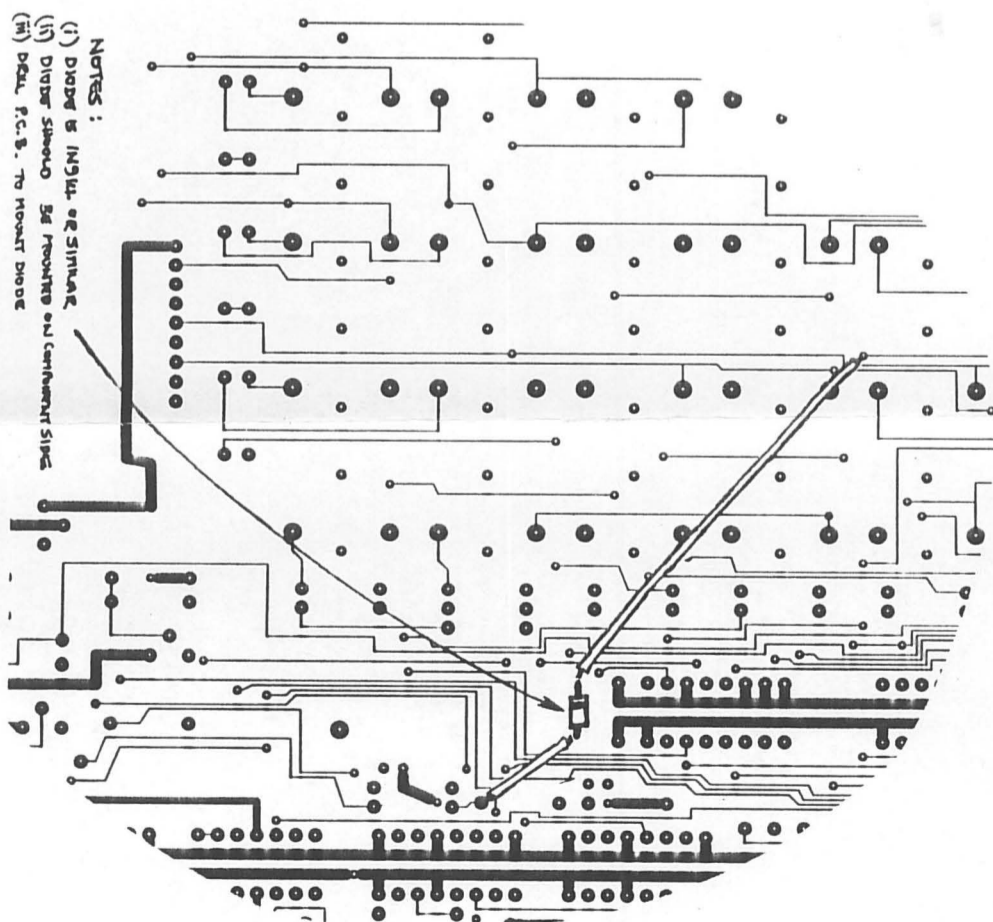
DETAILS OF MODIFICATION I.S.I.

- 1.5.1 Add 1N914 diode between the junction of R84 and D2, and 'Reset' (DIS 1/3). The cathode of the diode must connect to DIS 1/3. The diode should be mounted on the component side of the P.C.B. by drilling two holes in the P.C.B. Wire links should then be used to connect the diode into the circuit.

The modification ensures that an oscillator formed by IC27 and IC28 starts running when the unit is switched on.

Units supplied after 010284 have been modified by Rank Strand. Units supplied before 010284 should be modified as part of routine service or if the customer complains that the unit does not always operate in 'stand alone' mode.

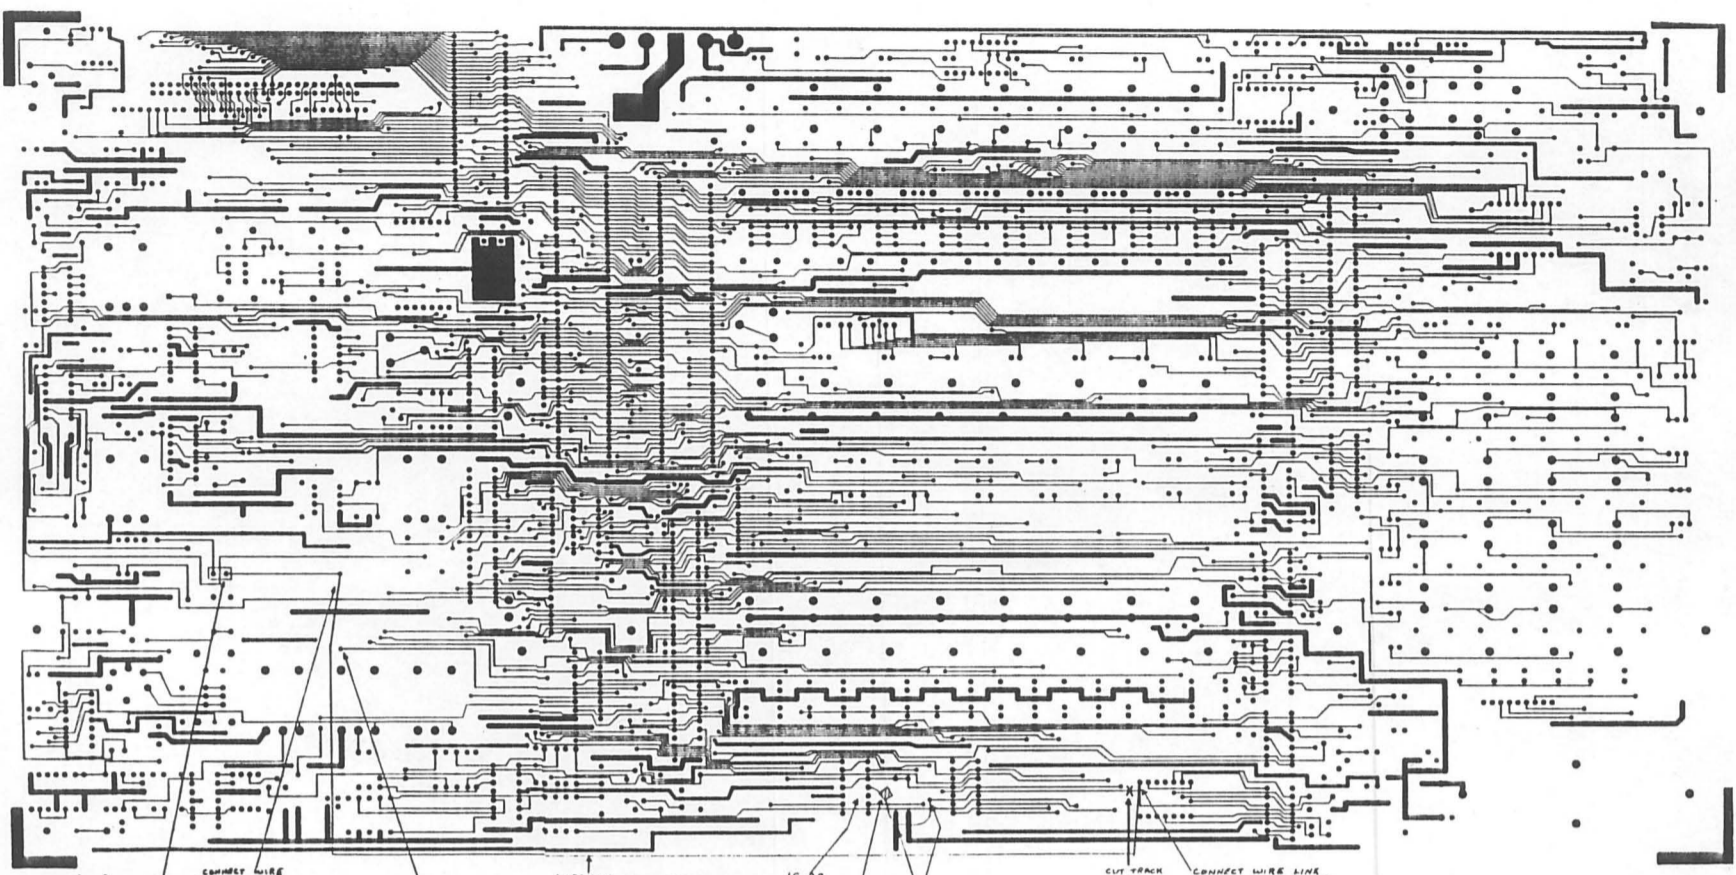
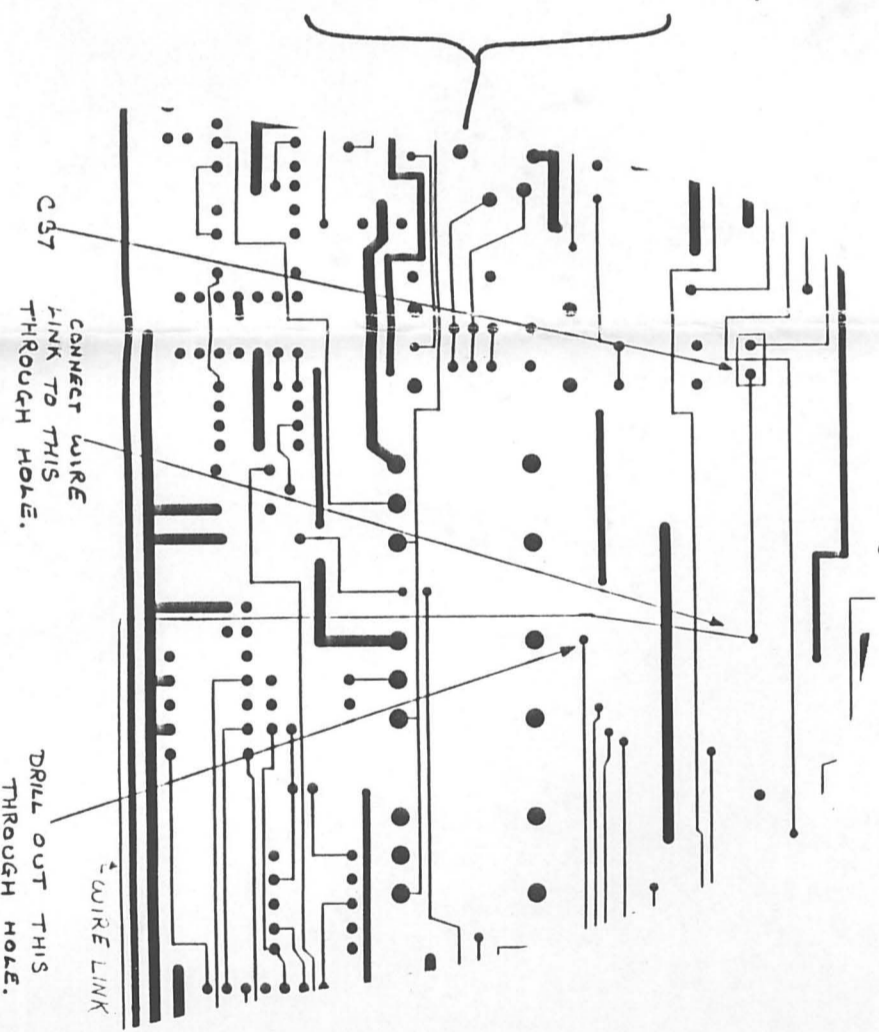
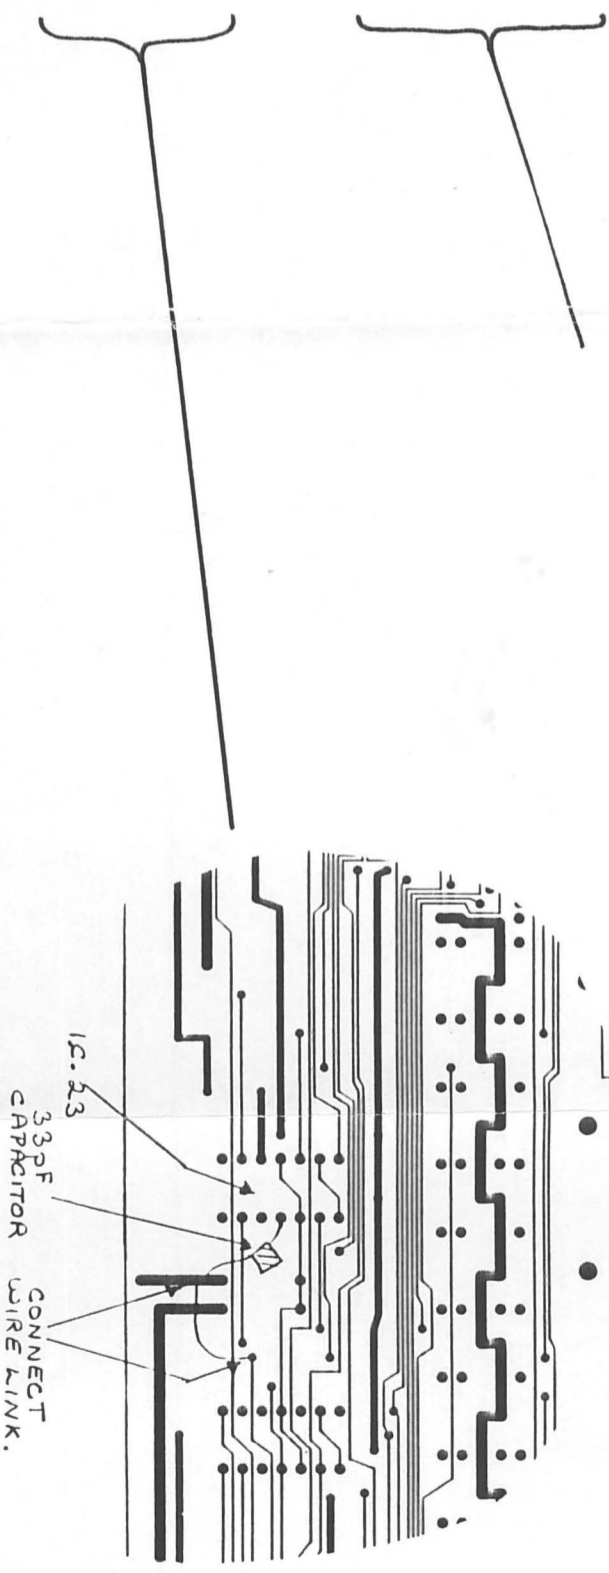
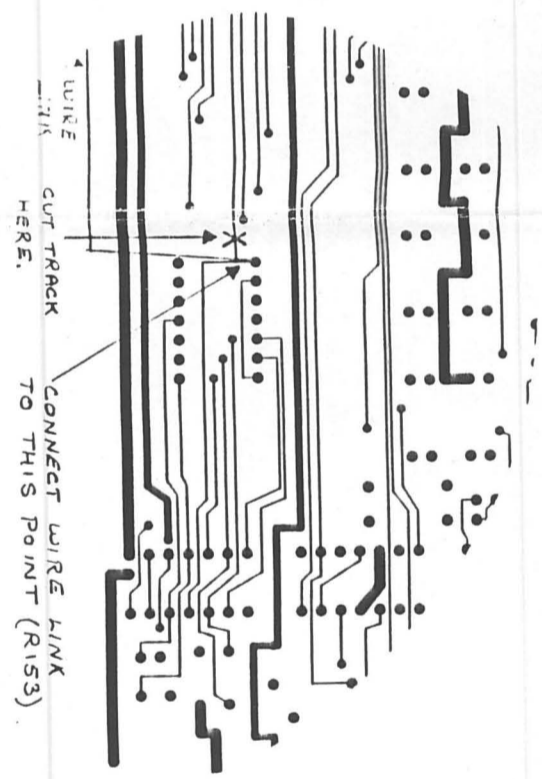
FIGURE 4.

- 1.5.2 Add 33pF chip ceramic capacitor between IC 23/4 and Analog OV (R136). Fit capacitor on component side of P.C.B.

The modification is to suppress noise on the D master.

- 1.5.4 Break track from IC 37/4 by R153. Drill out through hole towards other end of the same track, in the vicinity of RV14. Link this, now isolated, track to Analog OV between IC 23 and IC 24. Connect R153 to track from C37 with a PTFE insulated wire link. 'Tack' the wire link to the P.C.B. at approximately 60mm intervals. Implement modifications on the copper side of P.C.B.

Original track layout gives rise to cross talk between tracks, causing interference on Master H.

Units supplied after 140984 have been modified by Rank Strand. Units supplied before 140984 should be modified as part of routine service or if customer complains of interference on the D master.

Implement modification if interference is noted on Master H.
