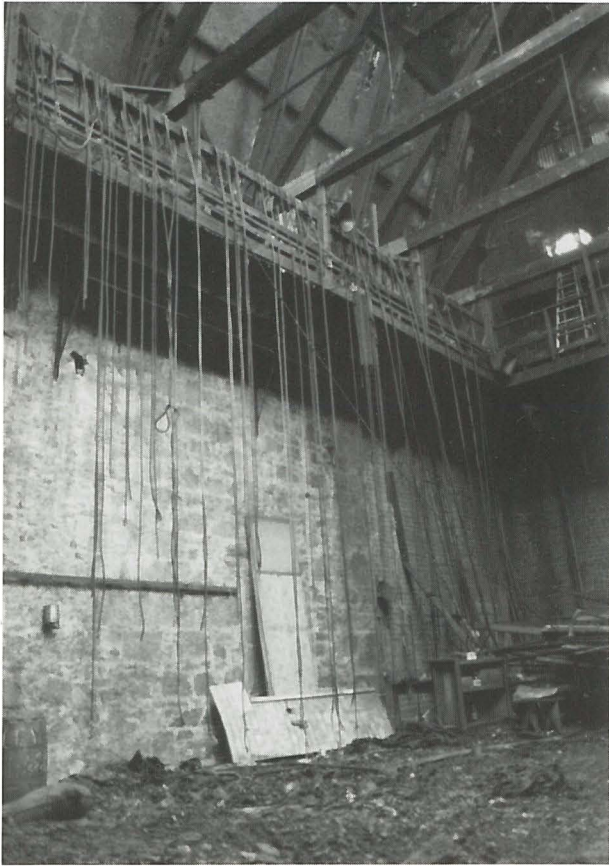
- ▲ Prompt side showing counterweight guides behind side masking and stage level guard panels. Fly gallery just visible at top of picture behind guides.
- ◀ Looking upstage OP after the fire, showing old timber roof trusses between which scenery was flown on hand lines

to disturb the above mentioned 150 year old walls, the solution was to build a steel structure free standing outside and above the old building, and mount the fly galleries just over the level of the bluestone. It had been originally planned to put the counterweights on OP side, with a loading door upstage, but planning permission was not obtained due to the narrow side street, so the weights and guides had to be on prompt side. To improve stage volume, the fly gallery, hence the flying operation and rope locking are offstage of the guides. Although unusual, it was agreed that the method is better than the cumbersome alternative of double purchase counterweights.

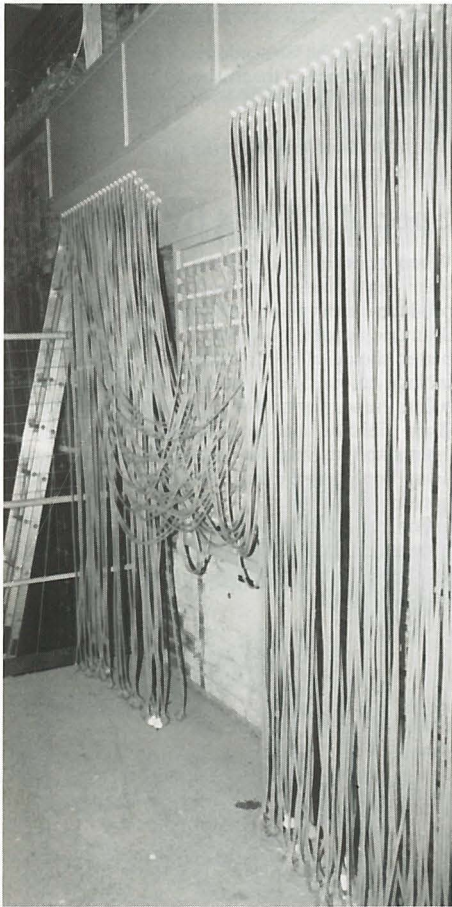
Lighting patch panel – Australian style.
