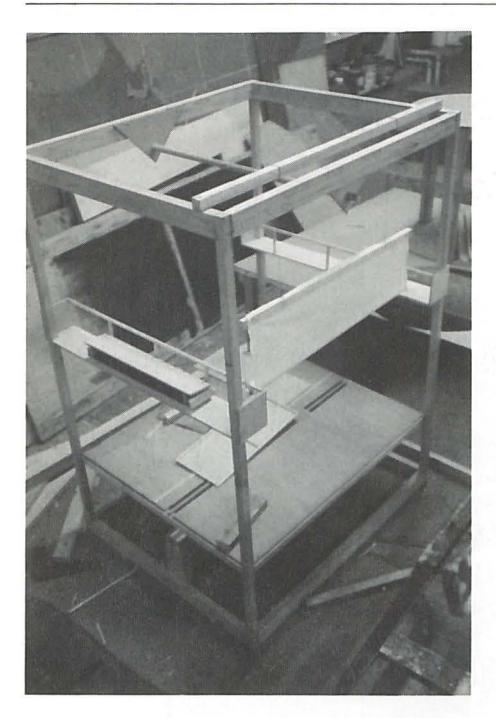
Picture of our first model, simply a large box with elements like lifts, tumble cloth and flying shafts being installed. Box made of softwood. Elements made of balsa and cord.

They were planning to make models of all lifting machinery, being a single trap downstage prompt side and grave trap centre, two bridges upstage of the grave and farthest upstage a row of three separately operated platforms each one being 4×8 .

In the end these were not all completed owing to the more conventional workload of stage management students, perhaps enthusiasm got the better of practical con-Initially the siderations modellers concentrated on taking detail photographs and measurements. Then scale drawings were made at the scale (1:12) the models were to be. The individual pieces of wood could then be cut to match the drawings. Obeche, spruce and pine were to be used in the construction. The most significant advantage that we held was that we seemed to be the only people using the building. I imagine that being alone in this empty theatre, deserted and yet still equipped, albeit a generation out of date, was a major part of its fascination. One problem we had to accept at that point was that the 'sliders' or lids to the traps had been rendered inoperative by additional joists being placed through the middle of them. In addition, the BBC in their tenure of the premises had laid a hardwood strip floor over the existing floor and extending over the orchestra pit. What with this and time constraints we couldn't adequately ascertain the details at the upper end of the bridges and traps.

At the end of this part of the work in 1983 we had a working grave trap and bridge. The upstage trio of platforms was made but not all working, and the pieces had been cut and partially assembled for the remainder. We were in fact pleased with the work because it had been thoroughly done and we had gained as a by-product drawings which will expedite future work.

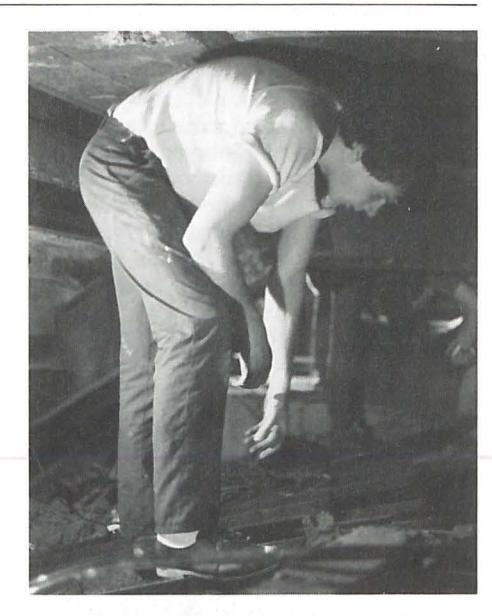
Researcher inside Upper Circle cantilever taking measurements.

support system for the Dress and Upper Circles. This is a relatively early example of cantilevering. The students crowded into both the cantilever areas dragging measuring tapes behind them as well as photographic equipment. I can only say that I have rarely seen such dirty people! This model is made of card sliced by a guillotine and then fabricated into the various sizes of steel beams. The beams are then glued together and given the faintest hint of black spray paint.

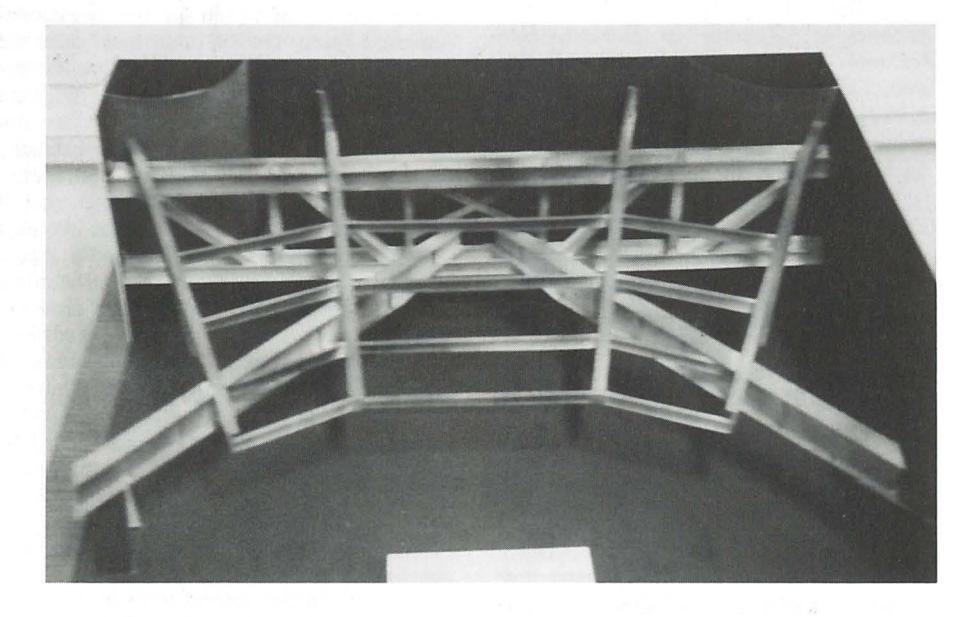
Model of the cantilever steelwork supporting the Dress Circle at the Playhouse Theatre, Charing Cross, installed 1905. Girders are made of white card with a fine black spray applied. The black card at rear and right represents the brick walls of the building.

We have also been able to make detailed drawings of both the Dress and Upper Circle cantilever systems and a model of the Dress Circle steelwork. This was possible because by April 1984 the architects and builders had extended their exploration of the theatre's structure beyond test holes dug in the basement and had made access into some of the building's voice spaces. This led to our undertaking a detailed study of the

The real value of the cantilever model is as a teaching aid to explain one of the most significant technical advances made available to designers of auditoria. Which soon became one of the watersheds in the history of theatrical buildings.
